Report 1855

RAPIDLY EMPLACED ANTIPERSONNEL OBSTACLE

Task 1M543312D46405

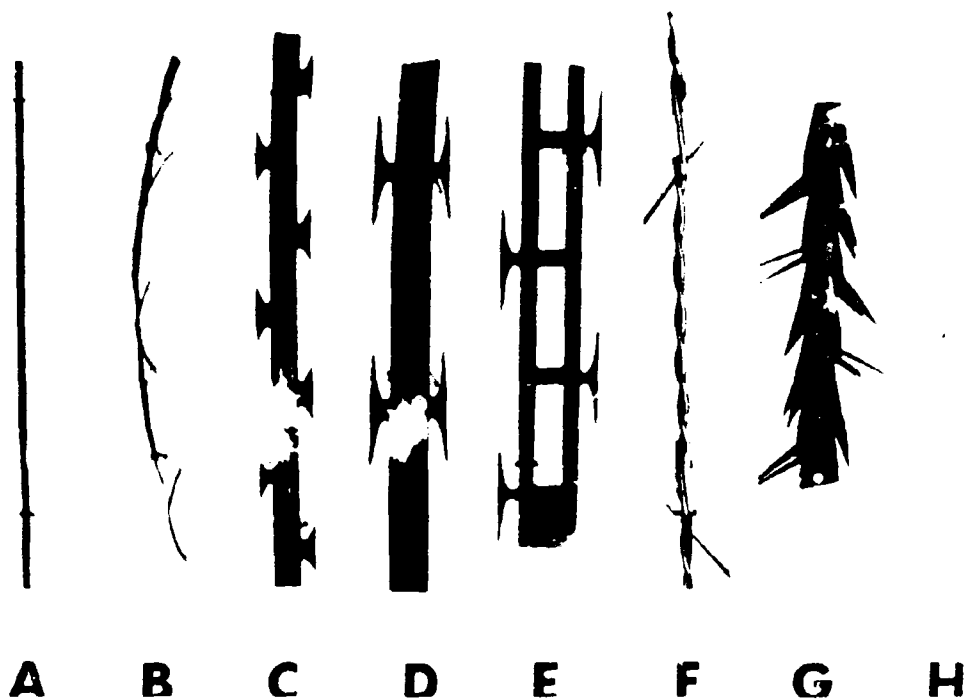
M13203

Fig. 1. Forms of barbed tape: (A) Tape developed by Universal Winding Company. (B) First tape developed by Firestone Tire and Rubber Company. Judged ineffective at 19 October 1961 In-Process Review. (C), (D), and (E) Forms of tape developed by Firestone Tire and Rubber Company under Contract DA-44-009-ENG-5083. Each tape was considered effective at the 12 December 1962 In-Process Review. (F) and (G) Harpoon wire and barbed tape considered in 1955 "Evaluation of Barbed Materials for Obstacles" experiments. Both were considered more effective than barbed wire. (H) German barbed tape.

to conduct preliminary investigations with 1/8-inch wide, 0.012-inch thick, barbed steel tape (shown as item A of Fig. 1). These investigations terminated with fabrication of a prototype model containing several reels of wound-spring steel-barbed tape. A pair of coil springs was designed to throw the wound reels of tape 3 feet in the air. Upon reaching the proper height, the reels of tape were designed to release and expand from the spring energy stored within the barbed tape. Through this process, it was intended that the tape be distributed uniformly over an area of 10 to 15 feet in diameter. Two prototype models were demonstrated to ERDL personnel on 17 September 1959. The barbed tape did not erect as expected but, rather, became completely tangled and, as a result, covered an area of only about 3 feet (as shown in Fig. 2). Although the device failed, the test established that the barbs and reel assemblies would have to be designed to prevent tangling of the tape during the uncoiling process, that each reel assembly would have to be placed in the obstacle device in a manner that would prevent interference between adjacent reels during erection, and that a supplemental energy source would be required to erect the tape, as the spring energy of the tape itself would be insufficient for this purpose.

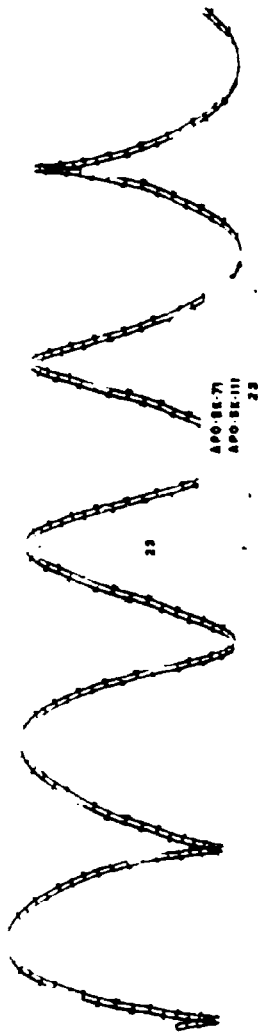
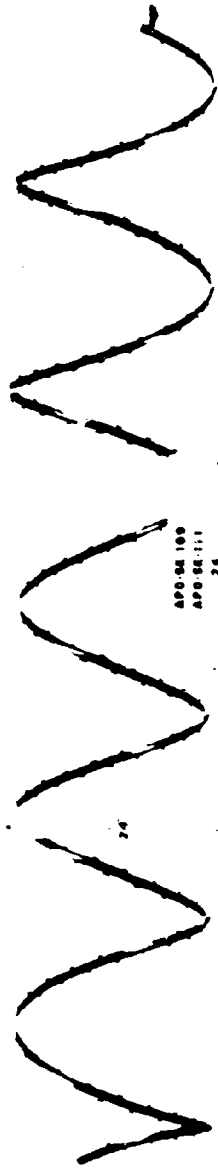
J12114

Fig. 4. The three tapes presented at 12 December 1962 In-Process Review. Each tape was judged to be effective.

c. Contract DA-44-009-ENG-5083. On 24 May 1962, a second contract was awarded to Firestone Tire and Rubber Company to develop more effective tape. The new tape had to stand twice as high as the tape developed in the previous contract. The section modulus, therefore, had to be increased by enlarging the width so that the tape would support itself to such a height. Three different tapes, shown in Fig. 4, were developed and presented for approval at an In-Process Review on 12 December 1962. One tape,  $3/4$  inch wide, was designed to stand 16 inches high. The other tapes,  $1\frac{1}{2}$  inches wide, were designed to stand 24 inches high. However, one of the tapes had rectangular sections cut out of the center to reduce weight. As a result, this lighter tape was not stable in the erected position. The user at the In-Process Review decided that all were effective and that the developer should design an obstacle, selecting whichever tape could be most conveniently applied to an erection device. Further, it was decided that height requirements would be eliminated from the military characteristics because the lesser height of barbed tape, compared to that of triple standard concertina, was compensated for by its greater width.

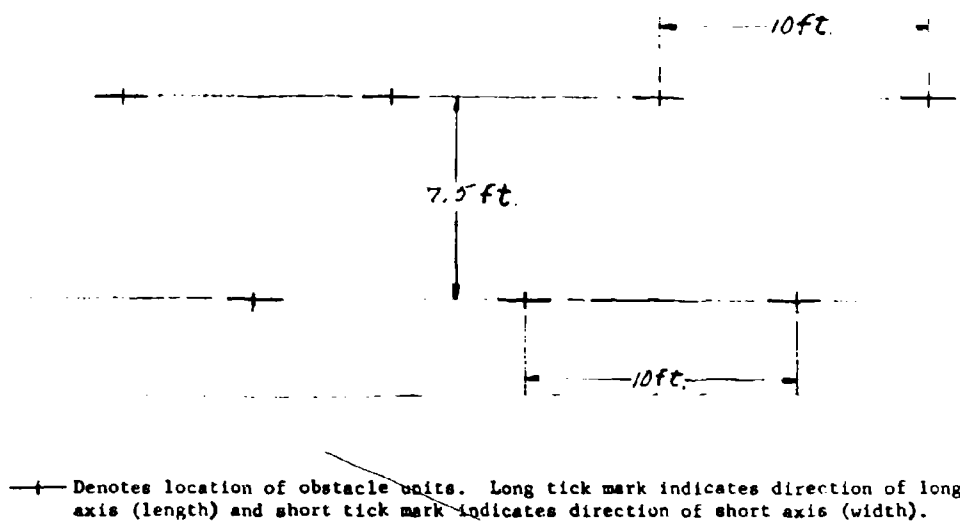
Fig. 7. Obstacle pattern, 10 feet by 7.5 feet, 2 rows.

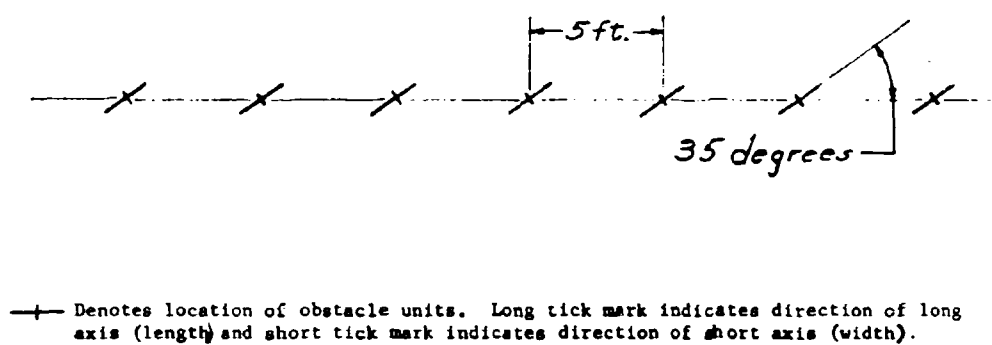
Fig. 8. Obstacle pattern, 5 feet at 35 degrees.

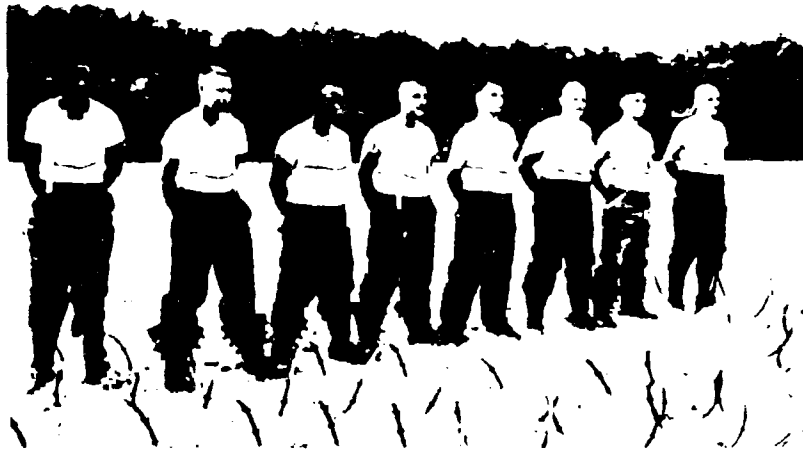
Fig. 9. Protective clothing worn by volunteers. (A) Personnel wearing protective trousers and fatigue pants. (B) Protective canvas coat. (C) Personnel completely dressed in protective clothing.

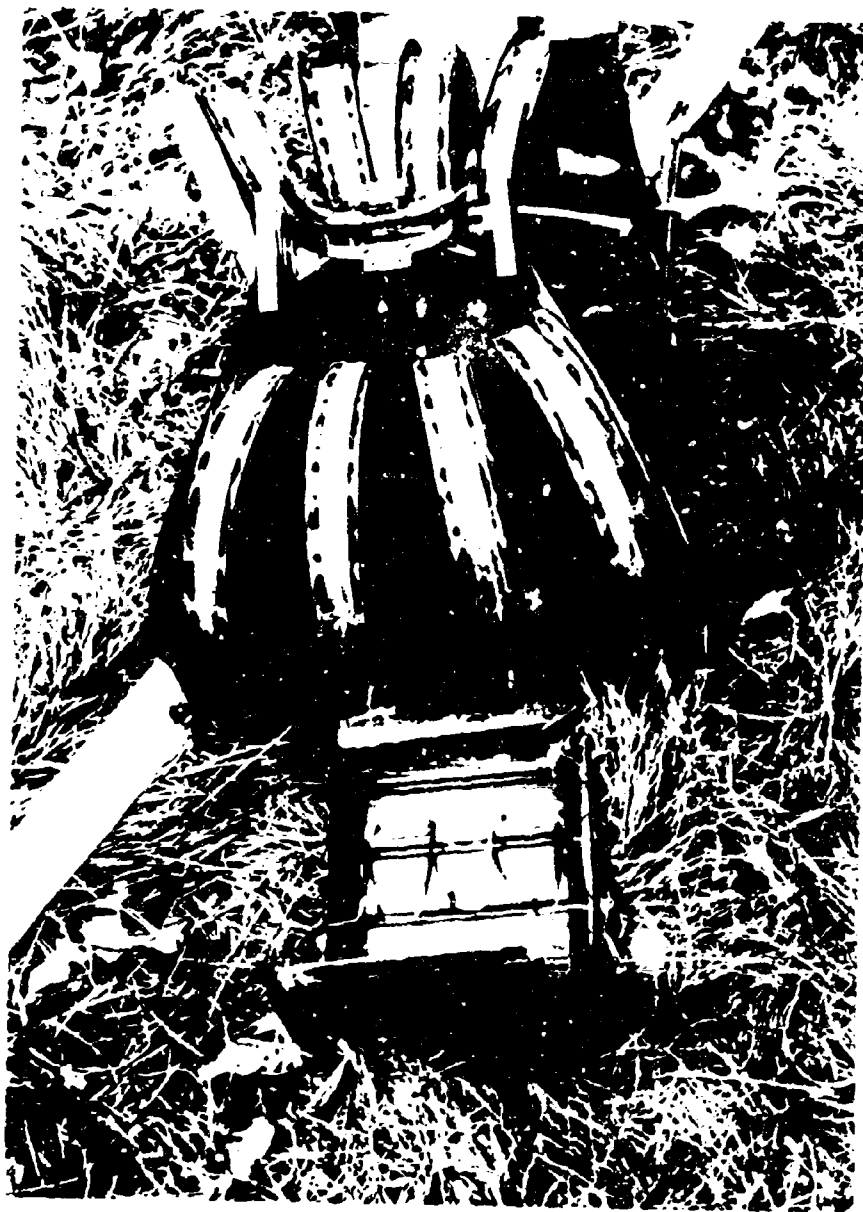
M12410  
Fig. 16. Obstacle unit after salt spray and one week of weathering.  
Accumulation of salt on the reels had no effect on tape expansion.

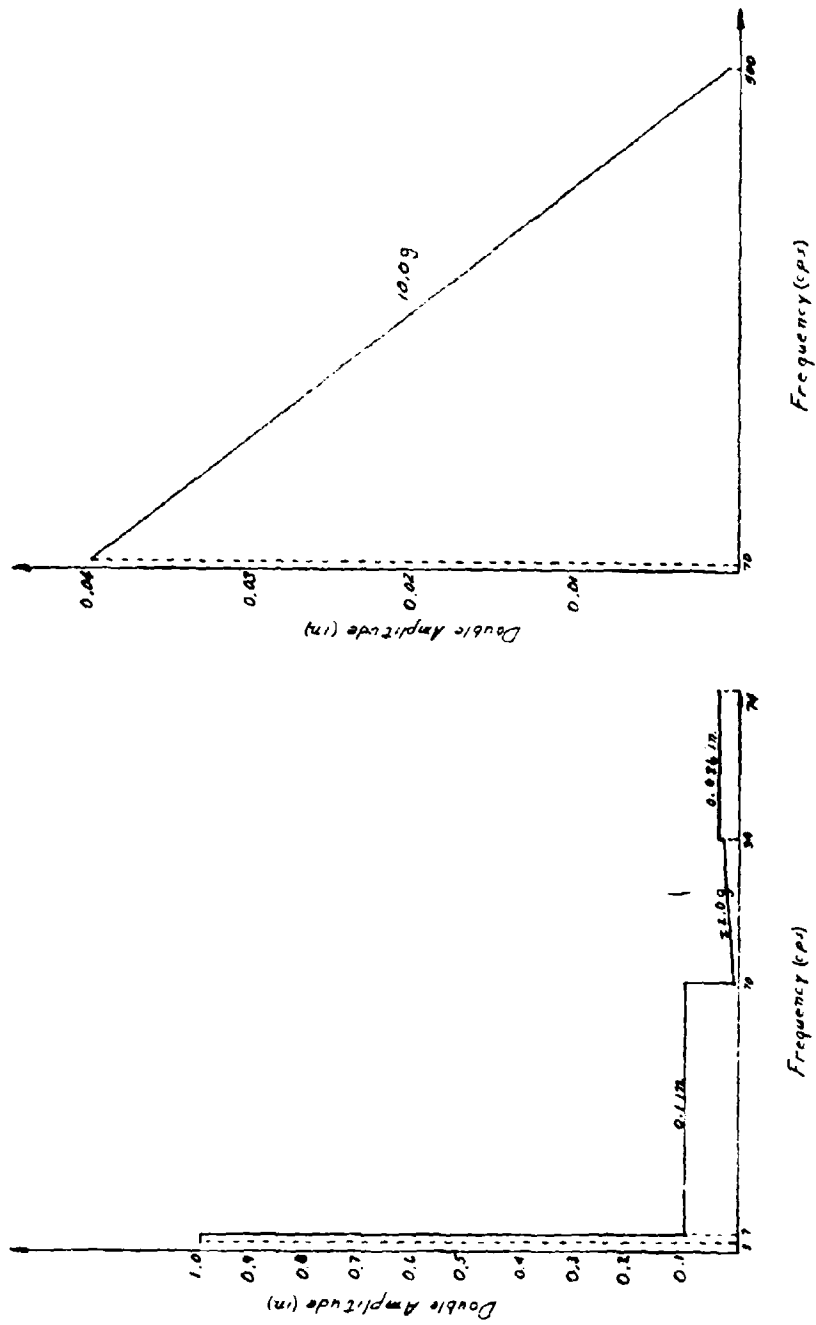
Fig. 18, Desired vibration curves.

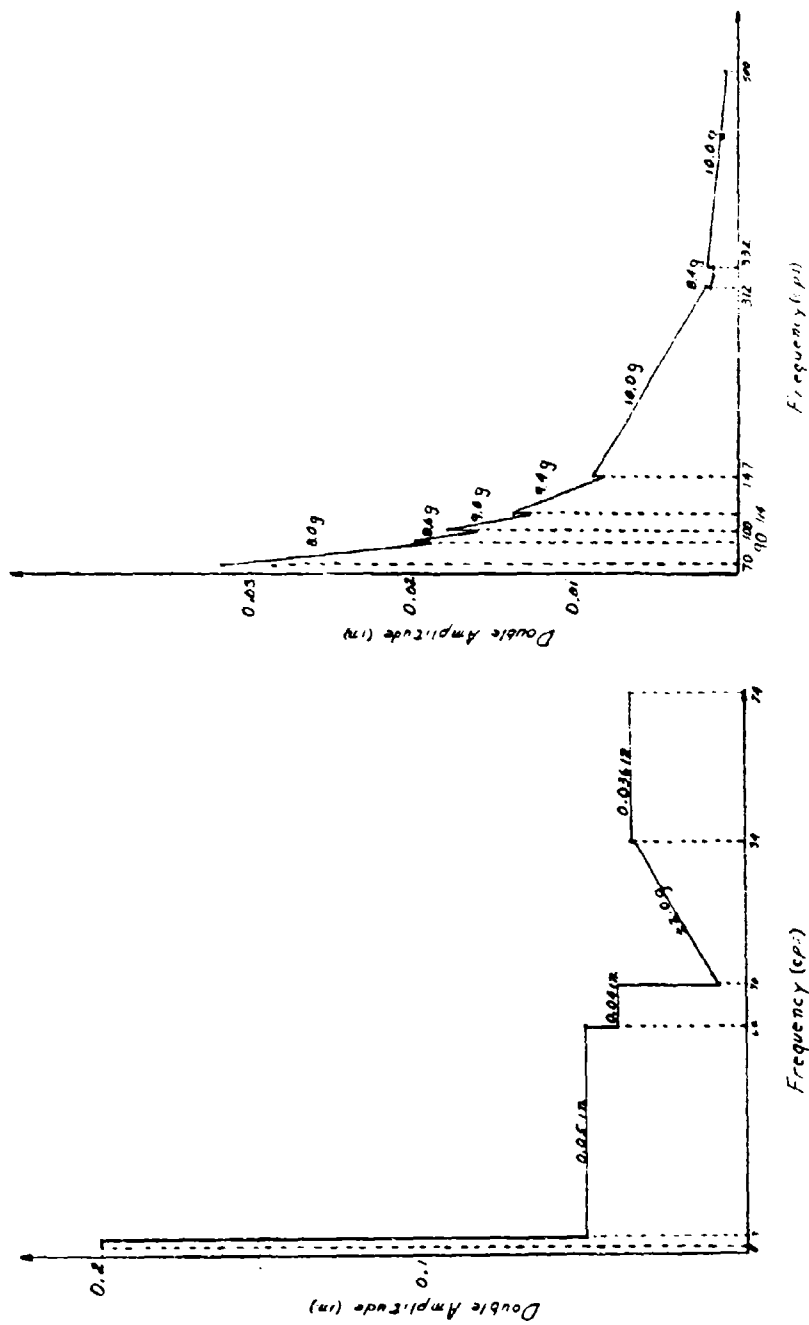
Fig. 19. Vibration achieved along x-axis.

(a) X-Axis. The vibration achieved is shown in Fig. 19. No resonant frequency was detected, and no damage to the unit was evidenced.

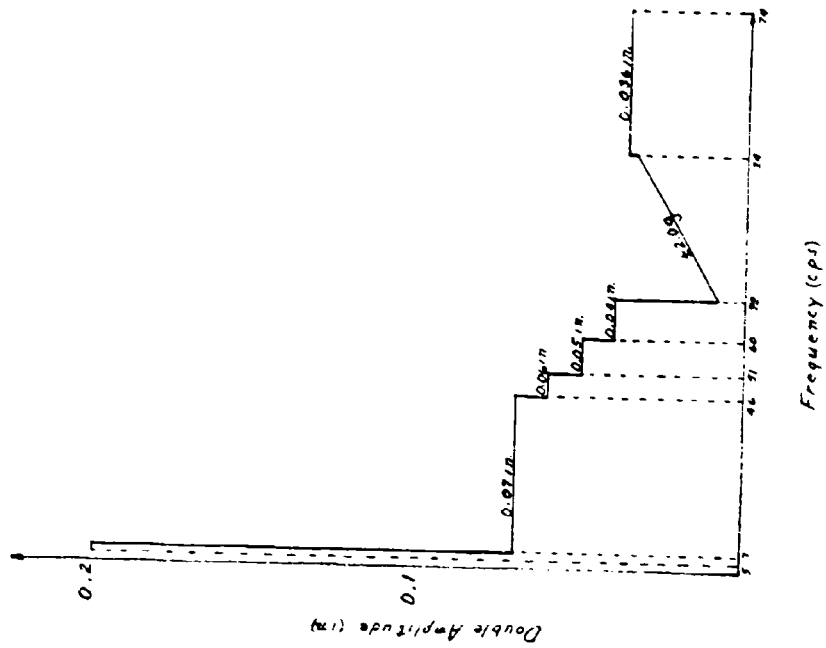
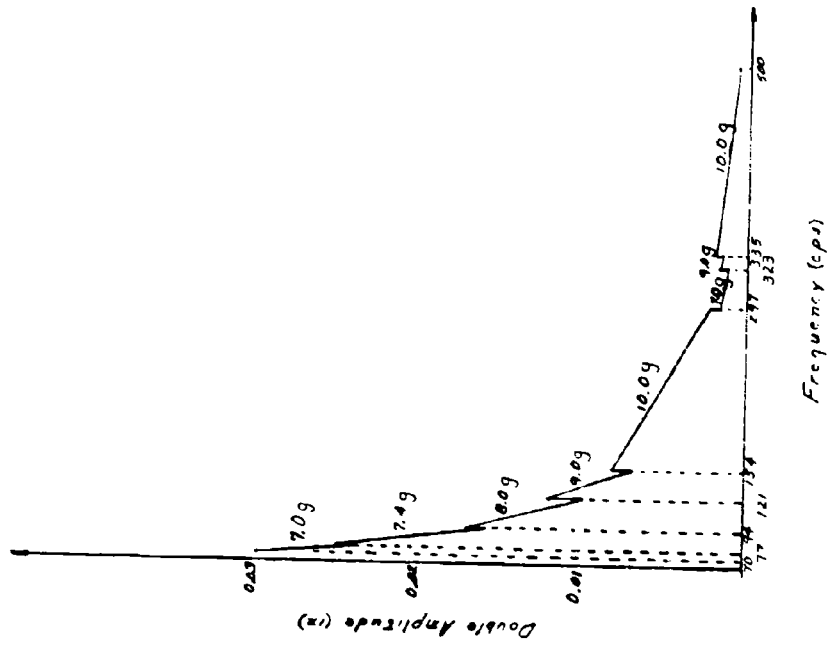
Fig. 20. Vibration achieved along y-axis.

1. At 13 cycles per second at 0.07-inch double amplitude; no evidence of damage.
2. At 23 cycles per second at 0.07-inch double amplitude; one end cover would not release because a barb of tape was stuck on the end cover channel at the top cover latch. The loops of tape in each coil began to slip horizontally over each other.
3. At 54 cycles per second at 0.036-inch double amplitude; loops of tape in each coil continued to slide horizontally.
4. At 195 cycles per second with 10-g force; sling No. 1 was binding in tape coil.
5. At 255 cycles per second with 10-g force; no evidence of damage.

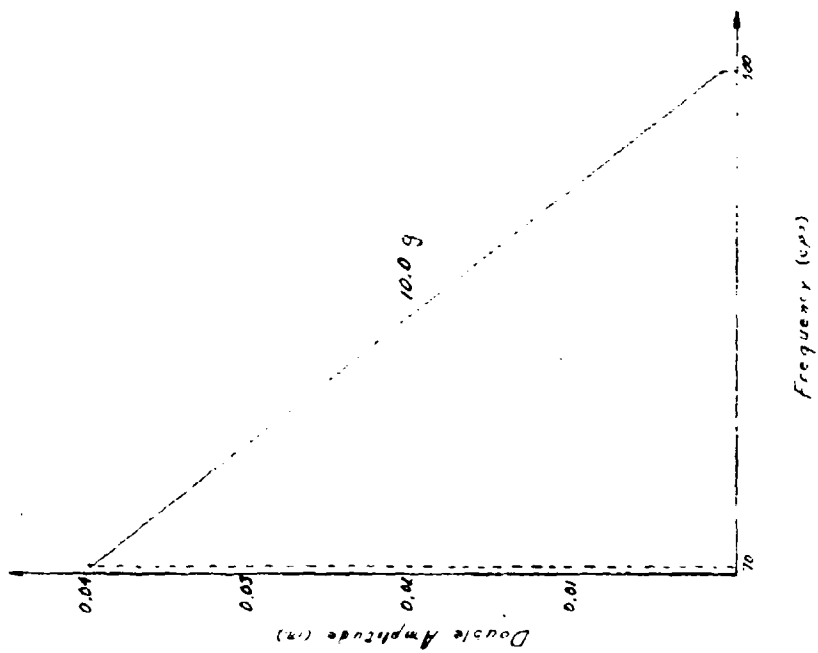
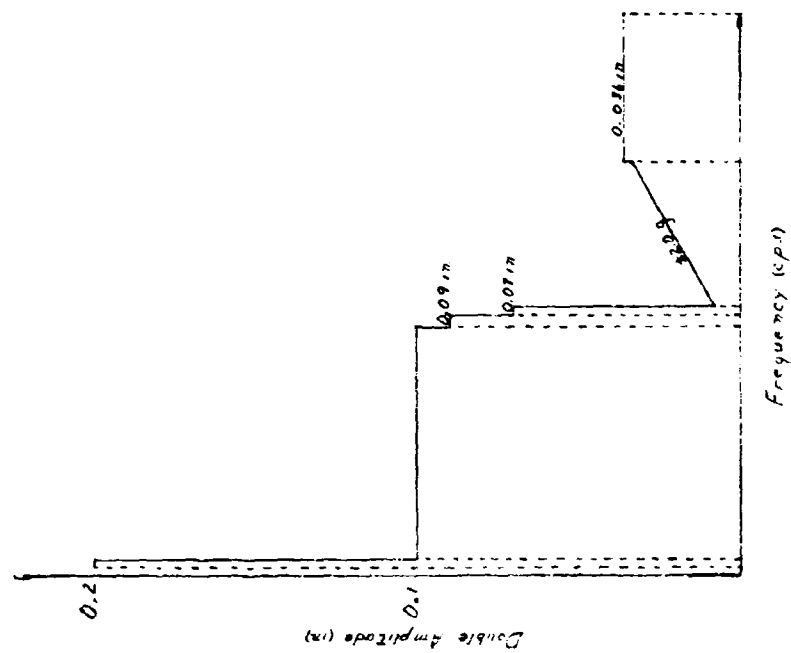
Fig. 21. Vibration achieved along z-axis.

(c) Z-Axis. The vibration achieved is shown in Fig. 21. Five resonant frequencies were detected. The results of 30 minutes dwell at each of these frequencies were as follows:

1. At 53 cycles per second with 0.1-inch double amplitude; no additional damage to the unit was evidenced.
2. At 61 cycles per second with 0.036-inch double amplitude; no additional damage to the unit was evidenced.
